Northside Partnership Healthy Communities Pilot Area Walkability Audit

Lin Zhao and Meadhbh Ni Lochlainn

April 2015

Northside Partnership Healthy Communities Walkability Audit

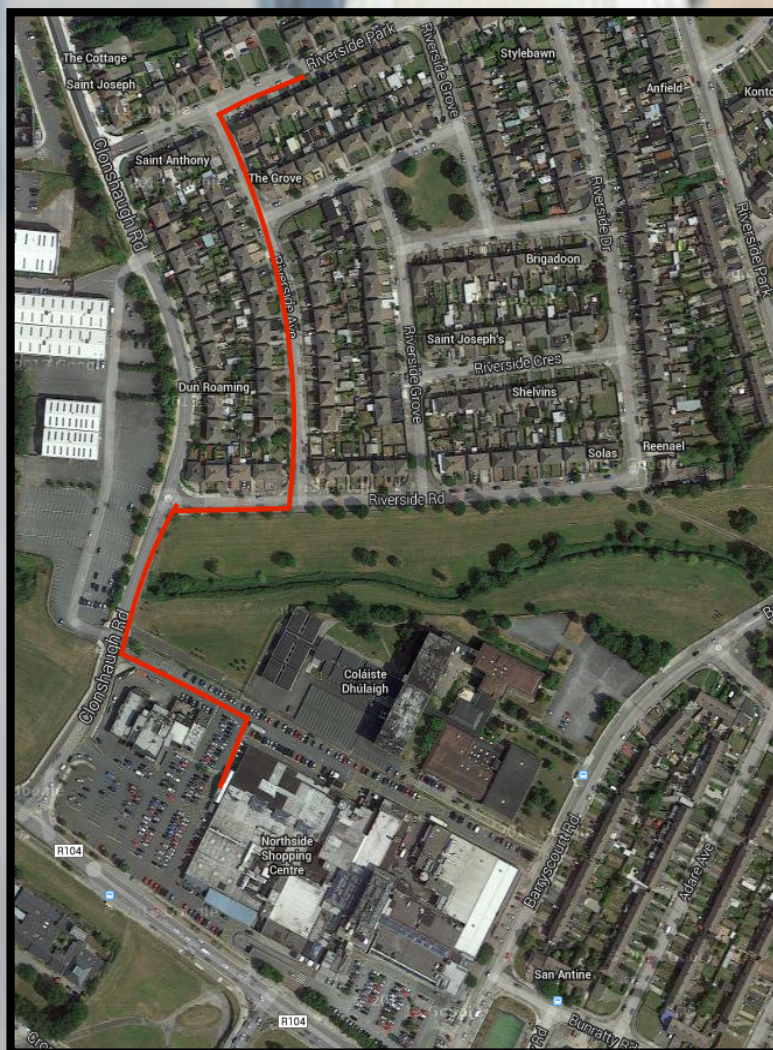
Figure 2.1: Adapted Google Maps Satellite Image of 500m route to Northside Shopping Centre

This section highlights the major issues in terms of walkability for the 500m route to the Northside Shopping Centre (see fig. 2.1).

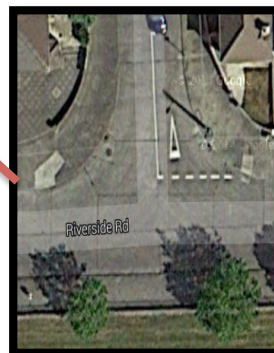
Figure 2.1.4: Google Map Satellite Images of corners at Riverside Ave. and Riverside Rd.

The corner radii along the 500m route measure approximately 9m in length (see fig. 2.1.5).

This is substantially larger than the 1-3m radius as is recommended for local roads in the DMURS. According to DMURS, 9m corner radii are only necessary for roads regularly carrying large vehicles, for example, in industrial estates.

These wide corners allow for motorised vehicles to move at a very high speed, posing a threat to pedestrians.

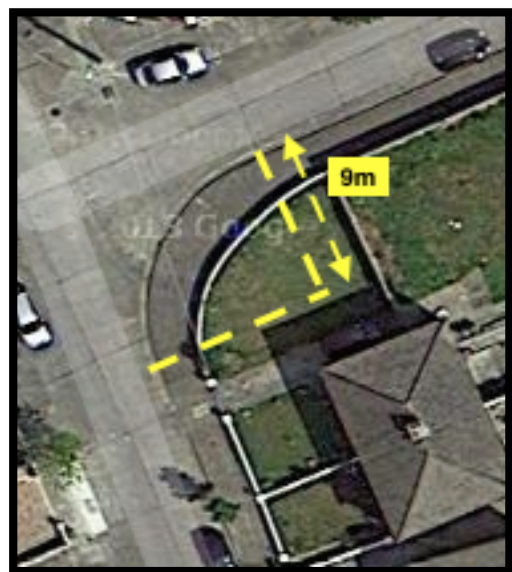
Figure 2.1.5: Adapted Google Map Satellite Image of corner radii.

Moreover, they require pedestrians to look back further to check for turning vehicles and they increase the distance a pedestrian needs to cover to cross the street, as is demonstrated in the next section.

Decrease corner radii to 1m to slow motorised vehicles to under 30km/h when turning. This should be done to a high standard, ensuring that the surface is even and not patchy, as can be seen in other retrofitted corners in the area.

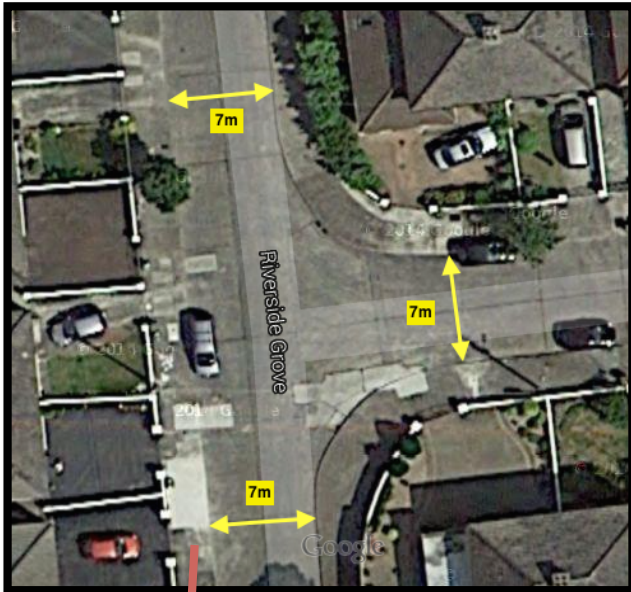
Figure 2.2.1: Adapted Google Maps Satellite Image of carriageway width at Riverside Grove and Riverside Avenue.

The carriageway width along the route is approximately 7m (see fig. 2.2.1), which is wider than the recommended 5-5.5m for local roads (DMURS).

Not only does this allow for motorised vehicles to move very quickly, it also means that pedestrians have to cover a large distance to cross the street.

In order to improve the pedestrian environment, it is recommended that the carriageways be narrowed to at least 5-5.5m (as per the DMURS guidelines) or install other traffic calming measures, such as chicanes (see fig. 2.9.2).

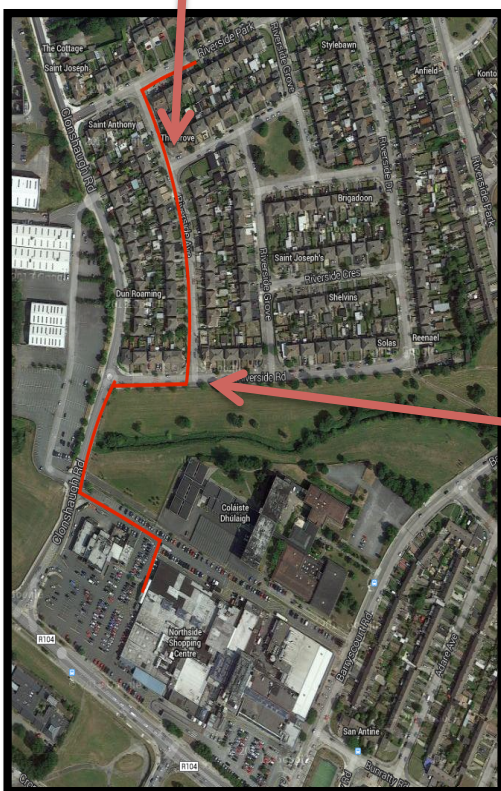
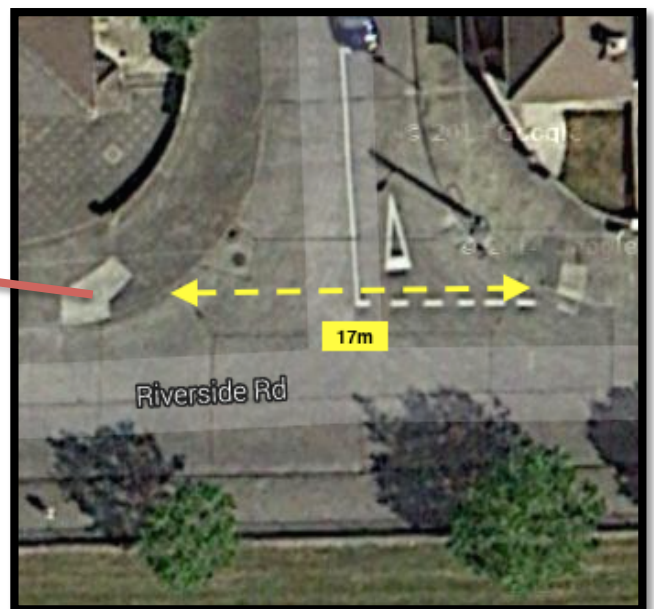
Figure 2.3.2: Adapted Google Maps Satellite Image of carriageway width at Riverside Road

In addition, the wide corners along the route (outlined in section 2.1) increase the crossing distance further, measuring approximately 17m (see fig. 2.2.2).

The difficulty of crossing due to cars turning corners at high speeds was experienced during the walkability audit.

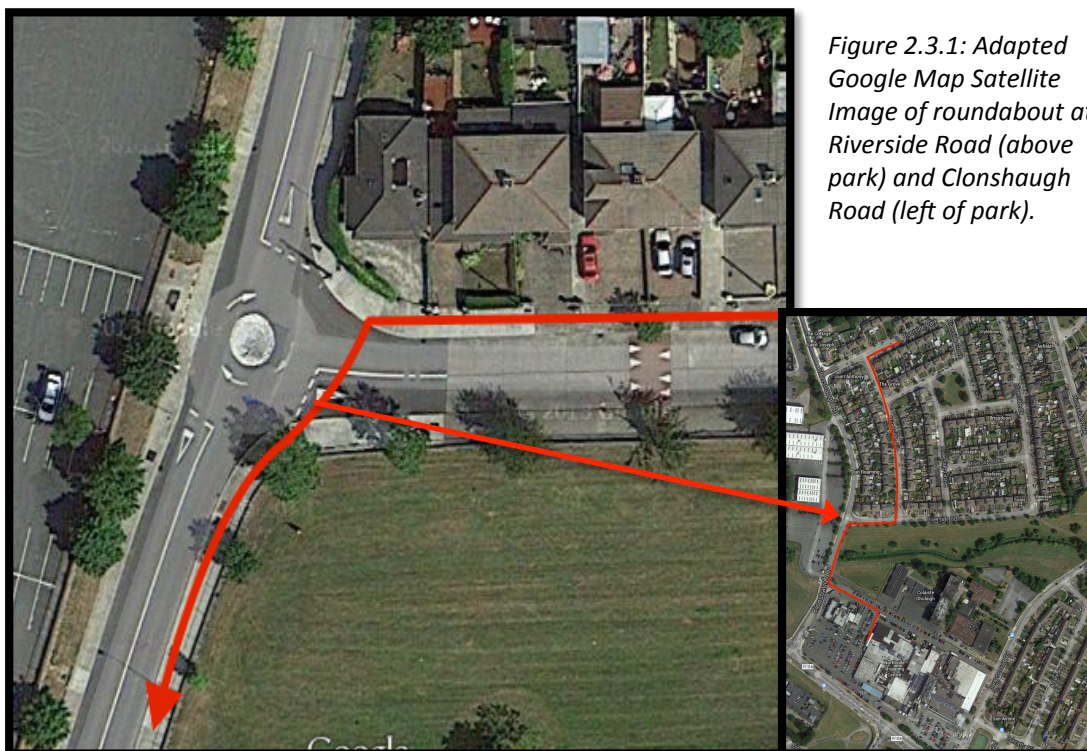
Figure 2.3.1: Adapted Google Map Satellite Image of roundabout at Riverside Road (above park) and Clonshaugh Road (left of park).

The roundabout shown in figure 2.3.1 poses a problem for pedestrians along the route. Firstly, it does very little to restrict car movement, as cars can drive over it. Secondly, there are no pedestrian crossing points. Thirdly, the wide carriageway and corner radii increase the crossing distance, creating an even greater barrier for pedestrians. In relation to junctions, DMURS states:

'[compact roundabouts] may be considered where vehicle flows are not sufficient to warrant full signalisation, such as on *Links*, and pedestrian activity is more moderate, such as in *Suburbs* and *Neighbourhoods* provided they are appropriately fitted with the appropriate pedestrian crossings' (p. 106) (emphasis added).

While the addition of pedestrian crossings could be one measure to address the issue, roundabouts are generally problematic for both pedestrians and cyclists as they are difficult to navigate; therefore, a different type of junction should be considered for this intersection.

Replace the roundabout with a stop and yield junction (see fig. 2.9.2) and install the appropriate pedestrian crossings.

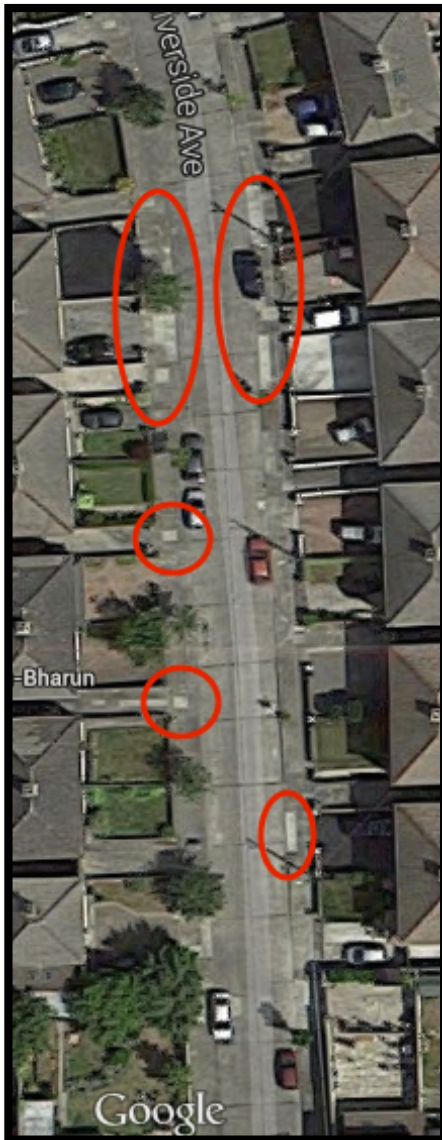
Figure 2.4.1: Adapted Google Maps Satellite Image showing patchy paving on Riverside Ave.

The quality of the paving is generally poor and could potentially cause people to fall. While most of the broken and uneven pavement occurs on Riverside Ave. (see figure 2.4.2 – 2.4.5), the paving for the entire route is patchy and generally unattractive.

Resurface the paving to increase the safety and attractiveness.

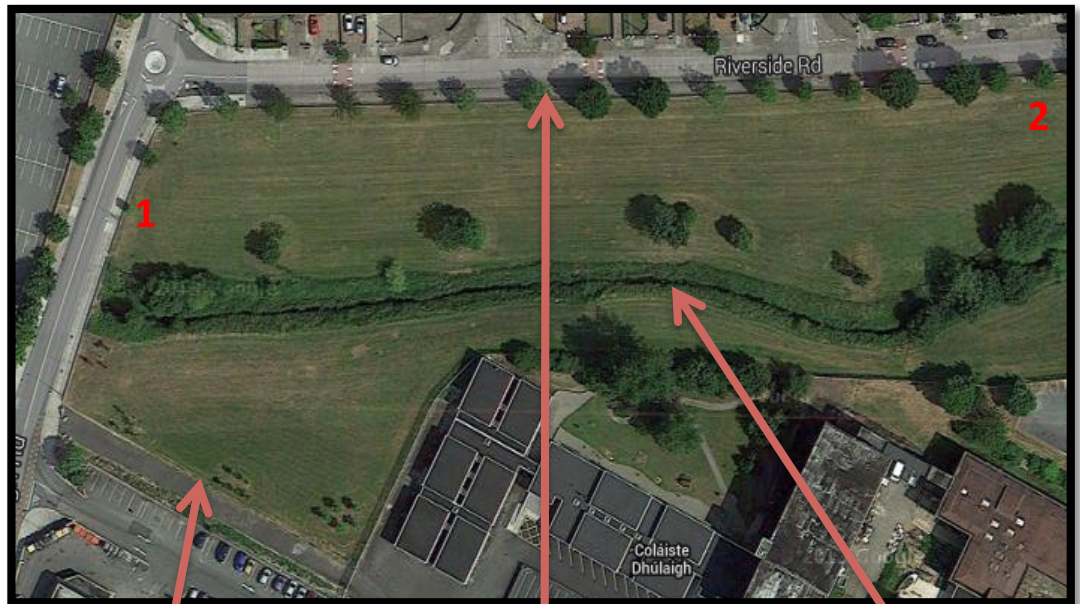
Figure 2.5.1: Google Maps Satellite Image of the entry points (1 & 2) and barriers to entry to the Stardust Memorial Park.

The Stardust Memorial Park is situated along the 500m route, yet it is not feasible to use the park when walking to the NSC. While there are some entrance points (see fig. 2.5.1 points 1 & 2), the fence reduces the permeability of the park (see fig. 2.5.2 and 2.5.3). Moreover, the stream (see fig. 2.5.4) also inhibits movement through the park.

To increase pedestrian mobility, more access points to the park and a crossway over the stream should be provided (see fig. 2.9.4). This can be seen in the eastern part of the Stardust Memorial Park (see section 3). In addition, the park should be well maintained so as to attract more users.

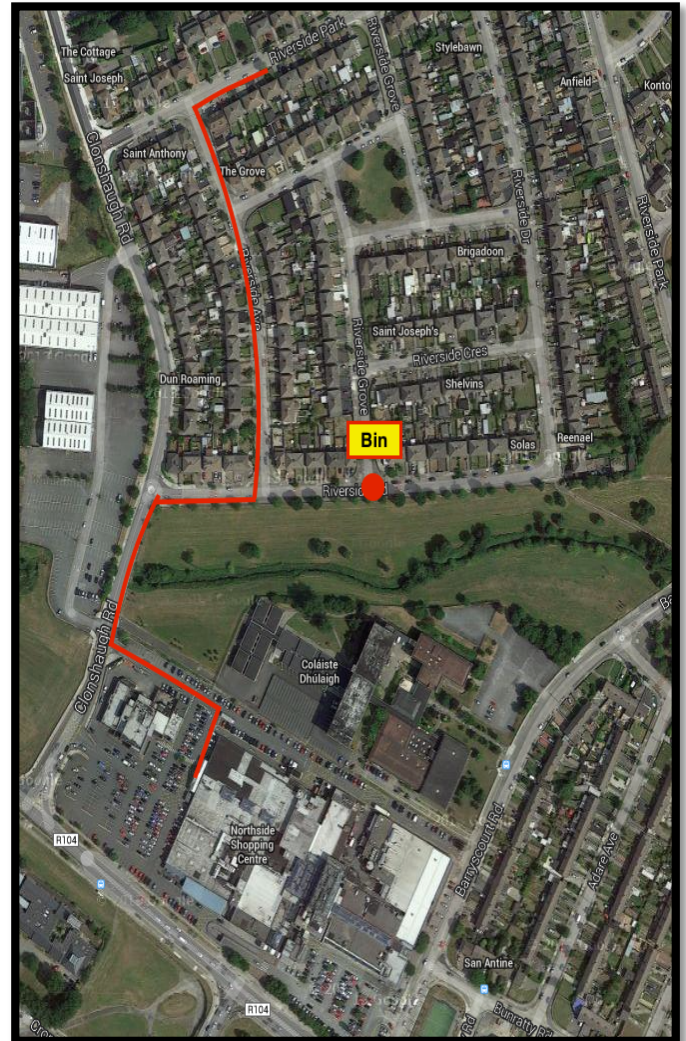
*Figure 2.6.1:
Adapted Google
Maps Satellite
Image showing
only visible bin
along the 500m
route.*

There is only one bin visible along the entire route, including inside the park (see fig. 2.6.1). There are also no bins or bags provided for dog litter.

Provide adequate bins and facilities for dog litter and ensure that the street and park are cleaned on a regular basis.

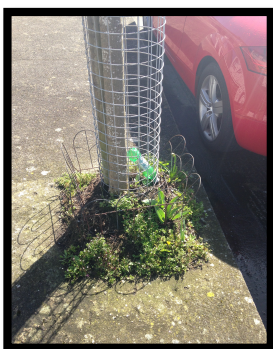
*Figure 2.6.2:
Photograph
of litter on
Riverside
Ave*

The extent of the litter observed along the route does not pose a major barrier to walking; however, it can appear quite unattractive. There are also instances of dog fouling.

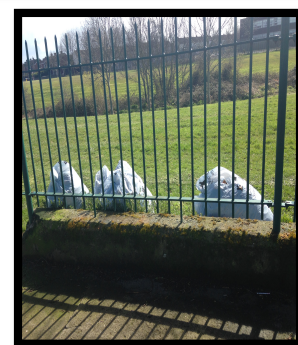
*Figure 2.6.4:
Photograph of
uncollected
rubbish bags in
the Stardust
Memorial Park.*

There is also a substantial amount of litter (and uncollected rubbish bags) in the park (see fig. 2.6.3 and 2.6.4), much of which is visible from the outside.

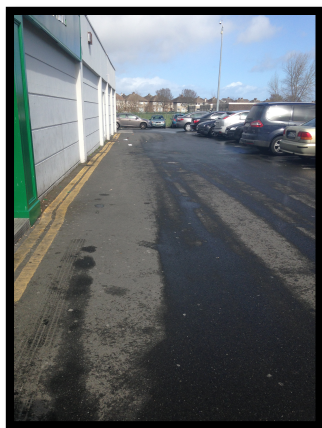
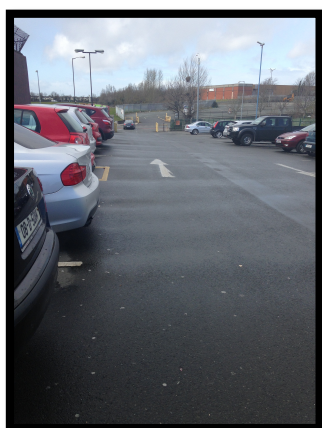
Figures 2.7.1 & 2.7.2: Photographs of car park at Northside Shopping Centre.

As can be seen in figures 2.7.1 – 2.7.3, there are no footpaths or walkways for pedestrians apart from the 3 crossings which are highlighted in figure 2.6.3. This makes walking very difficult, particularly during busy times.

Provide walkways to increase pedestrian mobility through the car park.

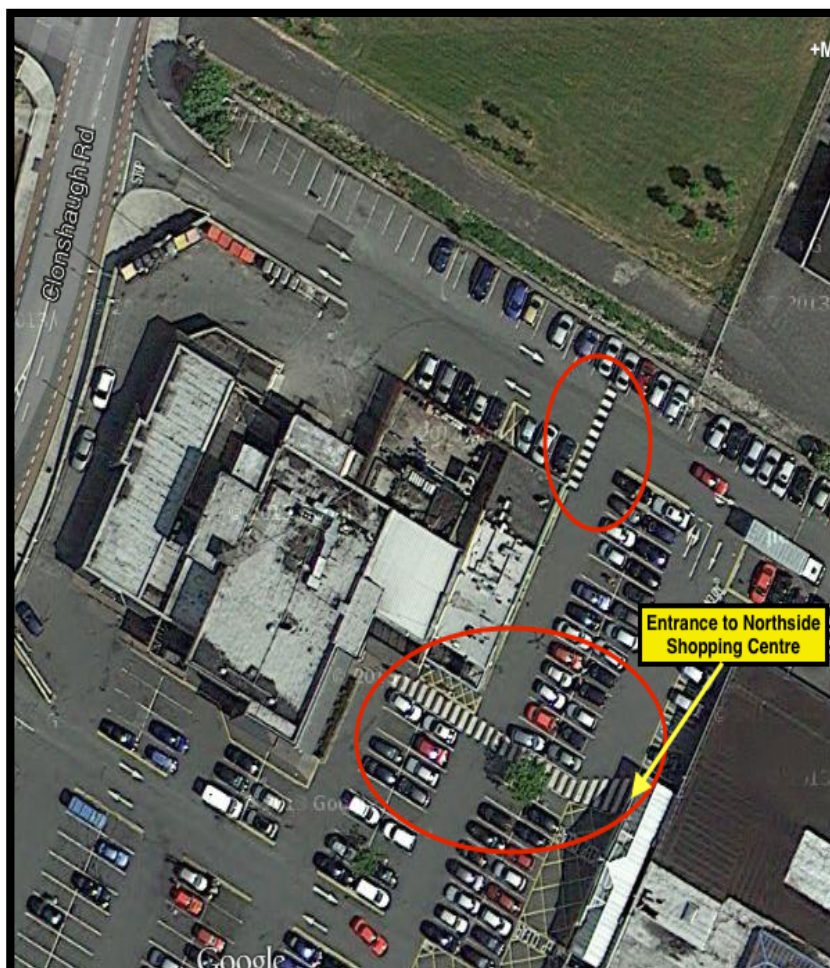
Figures 2.7.3: Adapted Google Maps Satellite Image of Northside Shopping Centre car park.

While this audit is primarily concerned with walkability, it was also observed that there is a lack of cycling facilities (e.g. lanes and parking spaces) at the shopping centre.

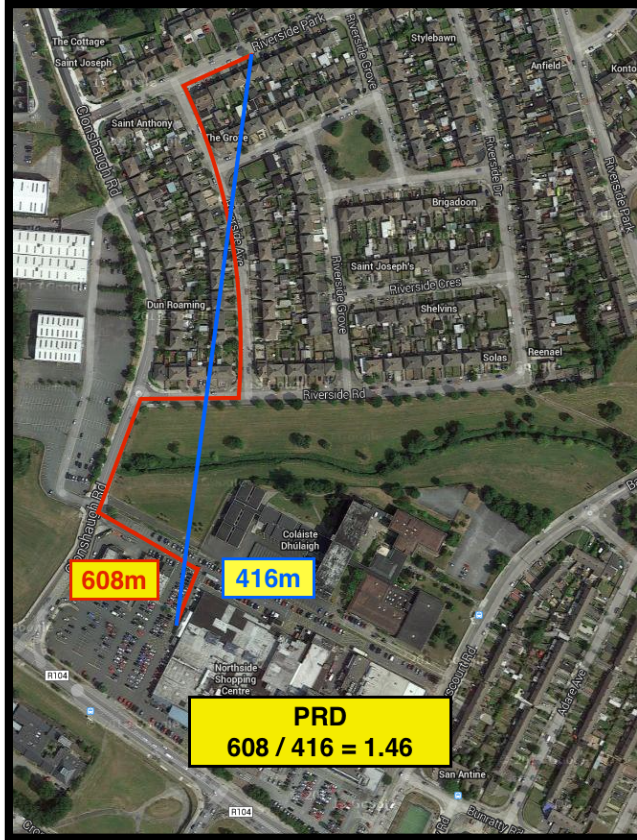
Figure 2.8.1: Adapted Google Maps Satellite Image showing Pedestrian Route Directness.

The permeability of the route was calculated using Pedestrian Route Directness (PRD), as shown in figure 2.8.1 (Randall and Baetz, 2001).

The PRD for this route is 1.46. A score of 1.5 or under is considered acceptable for a distance of under 700m (Randall and Baetz, 2001).

Nevertheless, providing access through the Stardust Memorial park could be one measure to both increase pedestrian mobility and make more use of the space.

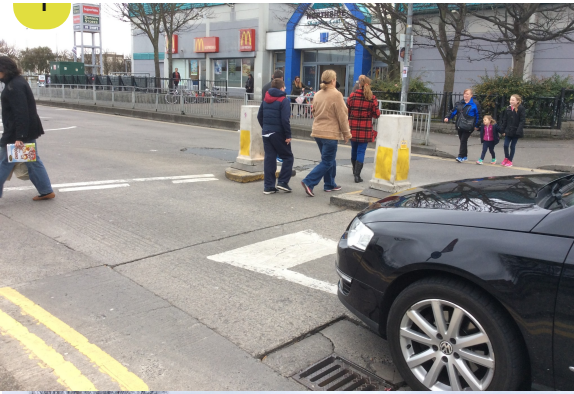
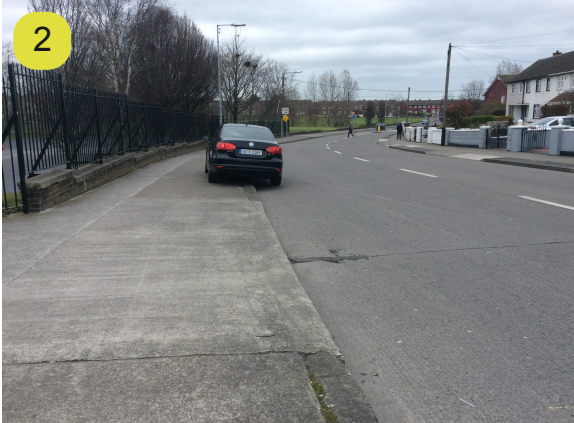
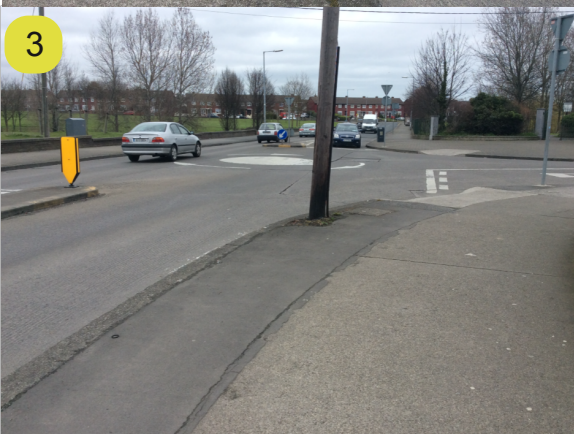
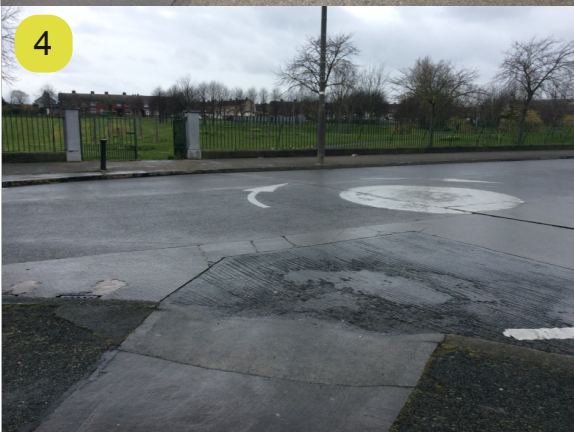
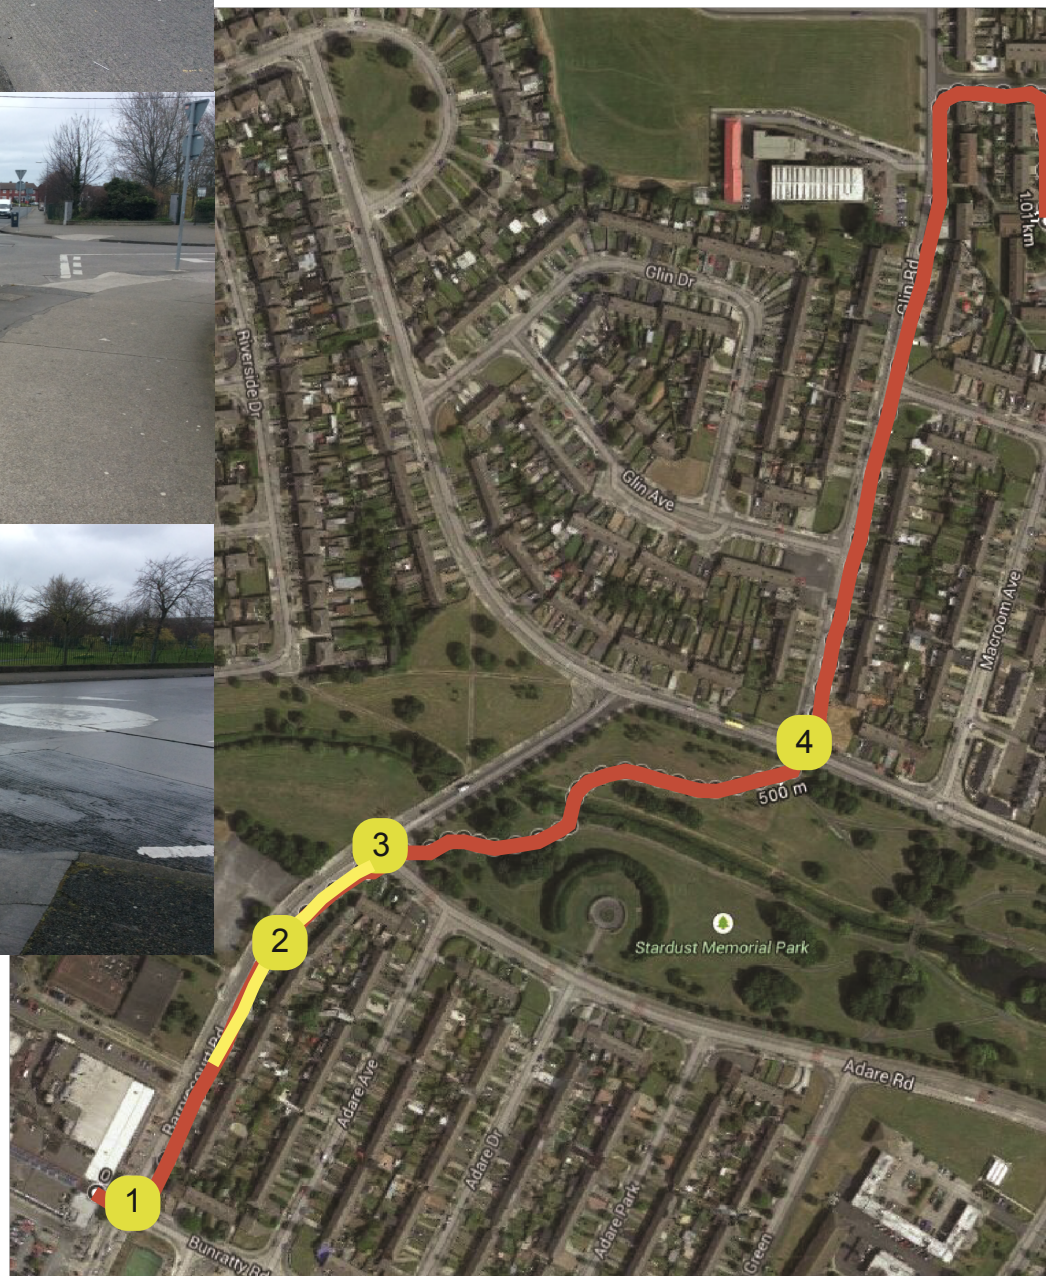
3.1 Pedestrian Crossing

1. **Roundabout no traffic lights**, located at the entrance of the Northside Shopping Center, 90% vehicle stop for pedestrian.

2. **136.62 meters distance between pedestrian crossing.**

Most of pedestrian go crossing just look at both side without any crossing facility. That could be a security risk.

“The minimum recommended distance between uncoordinated mid-block pedestrian crossings, or between a pedestrian crossing and an uncoordinated signal controlled junction is **100M**.”

3. **Roundabout no traffic lights**, located at the main gate of the Stardust Memorial Park, 50% vehicle stop for pedestrian.

4. **Roundabout no traffic lights**, located at the second gate of the Stardust Memorial Park, just 10% vehicle stop for pedestrian.

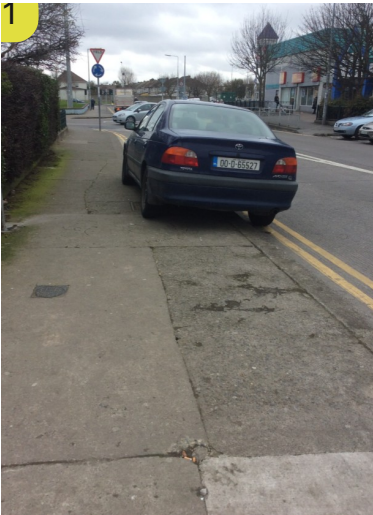
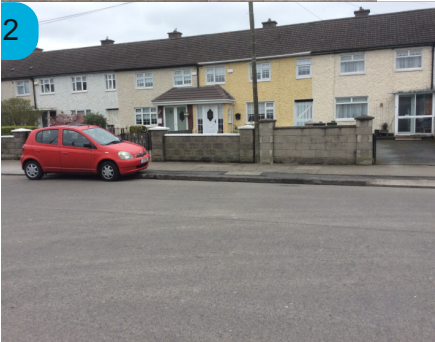
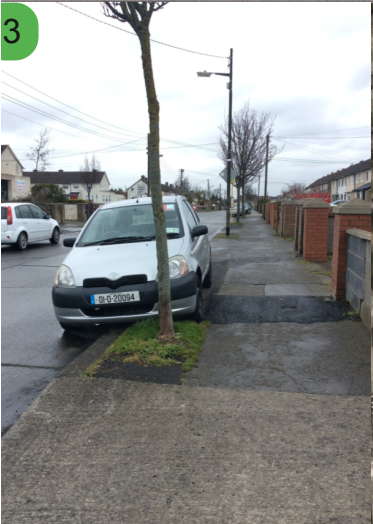
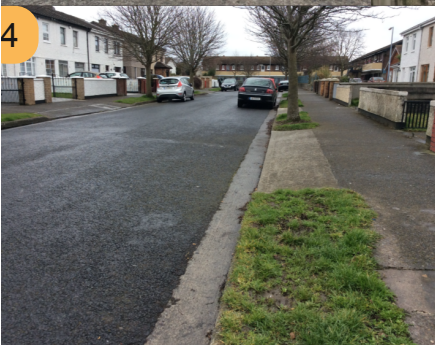
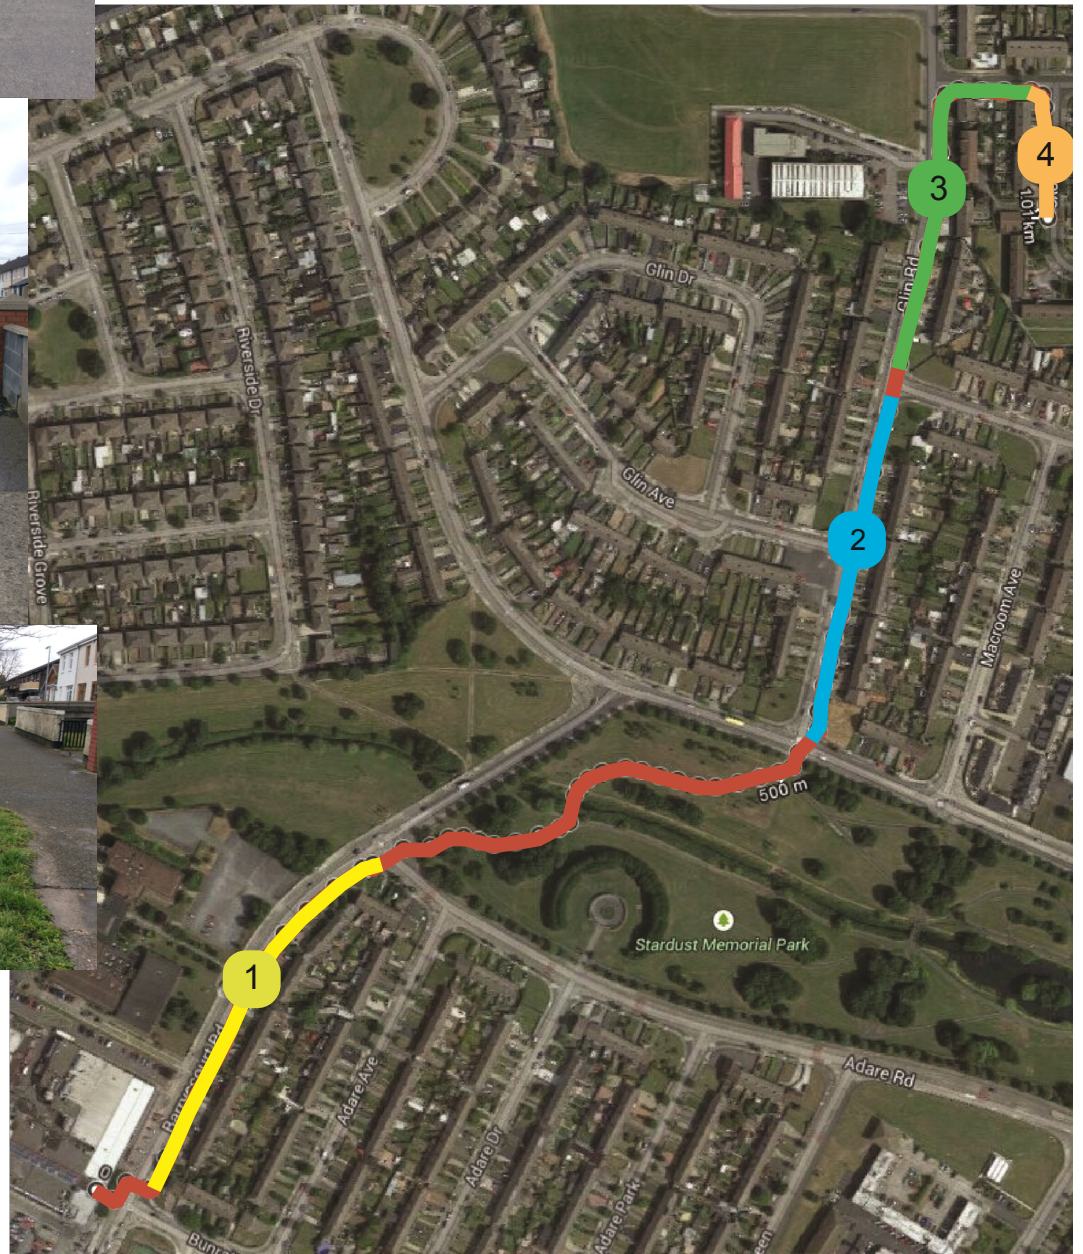
3.2 Parked Cars

All the road along this 10-min Walking Route have **NO** Street parking facilities.

The 10-min walking route been divide for FOUR parts showing in the map.

The 1, 2 and 3 parts are road which have certain traffic flow, **car parked on the footpath**.

The 4 part is Glin Grove just a few traffic, **car parked on the street**.

Among this 10 minutes pedestrian catchment just have two car parks located beside the Northside Shopping Centre, among this 10 minutes pedestrian catchment area do not have any on-street parking and loading facilities. Another reason is the parking appeals officer lack of supervision in this area. These two situations made random parked cars all along this 10 minutes pedestrian catchment.

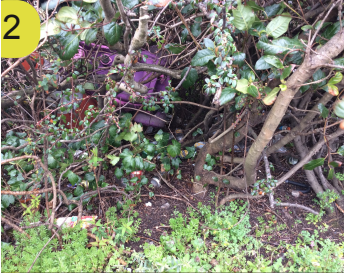
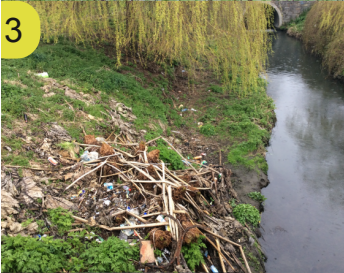
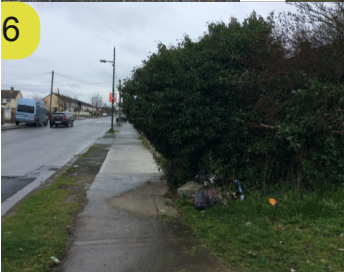
3.3 Footpath Quality and Litter

1. **Poor quality** of footpath.
2. **Litter** among plant.
3. **Litter** under the bridge.
4. **Poor quality** of slope to let cars drive into parking garden.
5. **Poor quality** of footpath.
6. Lush vegetation **blocking** the footpath.
7. **No clean-up** after mowing the lawn, made the footpath dirt and slippery.

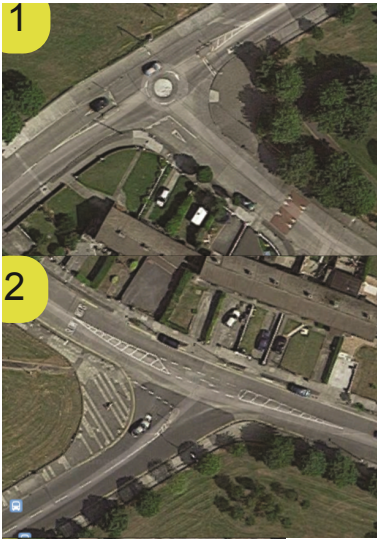
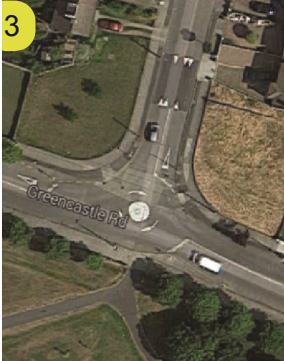
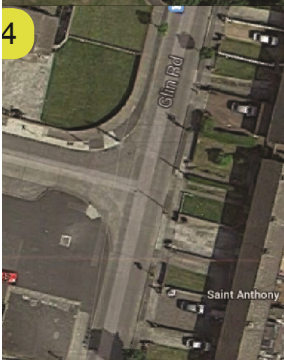
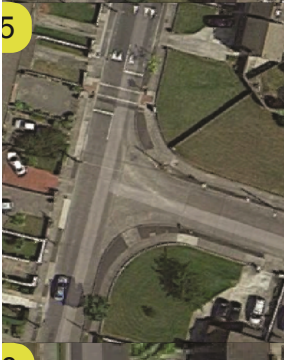
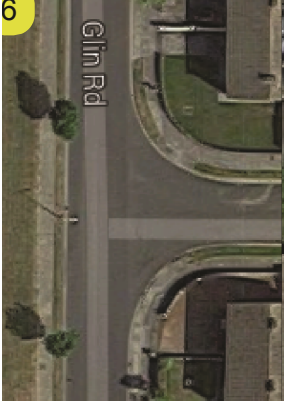
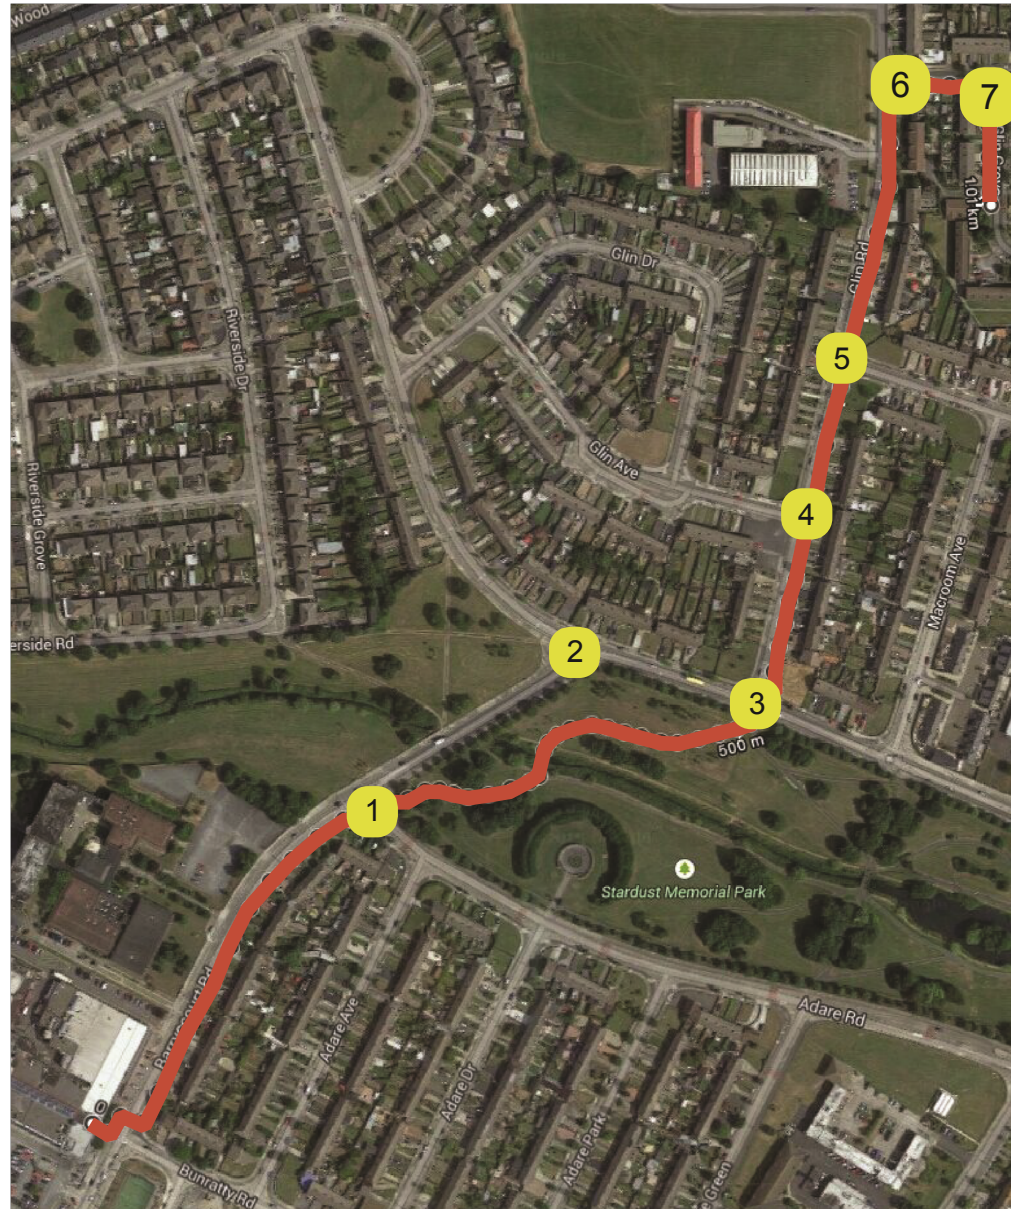
3.4 Corner Radii

1. South Corner Radii is 4.5-6m, North Corner Radii is **over 9m**
2. West Corner Radii is 4.5-6m, East Corner Radii is **over 9m**.
3. West and East Corner Radii both **over 9m**.
4. South and North Corner Radii both between 4.5-6m.
5. South and North Corner Radii both **over 9m**.
6. South Corner Radii is 4.5-6m, North Corner Radii is **over 9m**
7. West Corner Radii is 4.5-6m, East Corner Radii is **over 9m**.

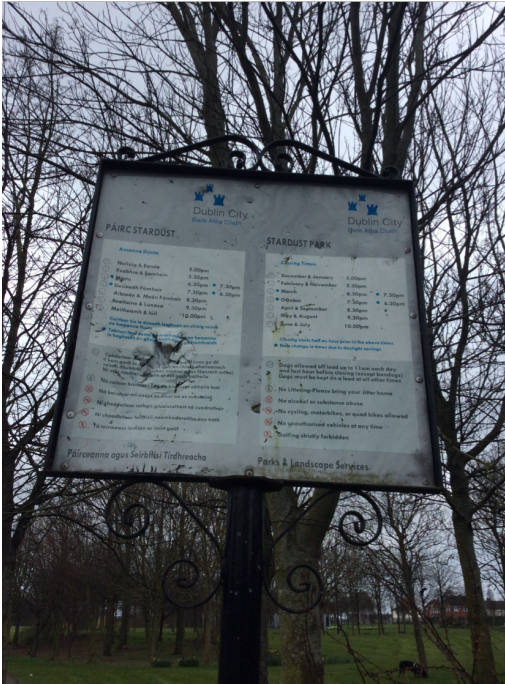
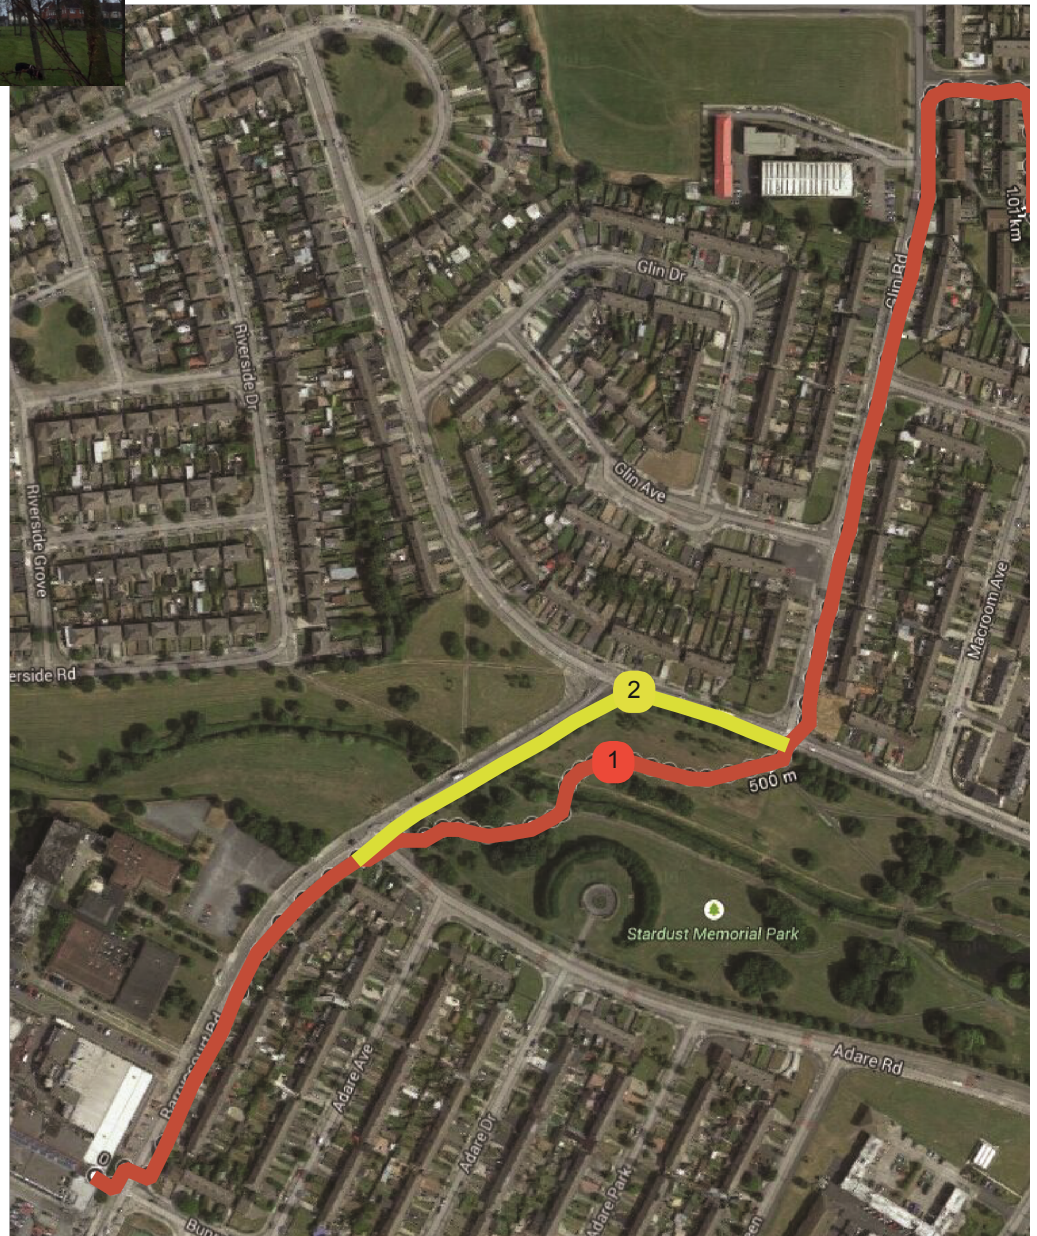
3.5 Park Access

According to the closing times of Stardust Memorial Park, there might be a second route for pedestrian to use when park closed.

Route 2 just **7.8 meters** further than Route 1. The distance is not a big problem, but pedestrian like to choose route 1 - go through the park for **safer, environmental friendly and relax.**

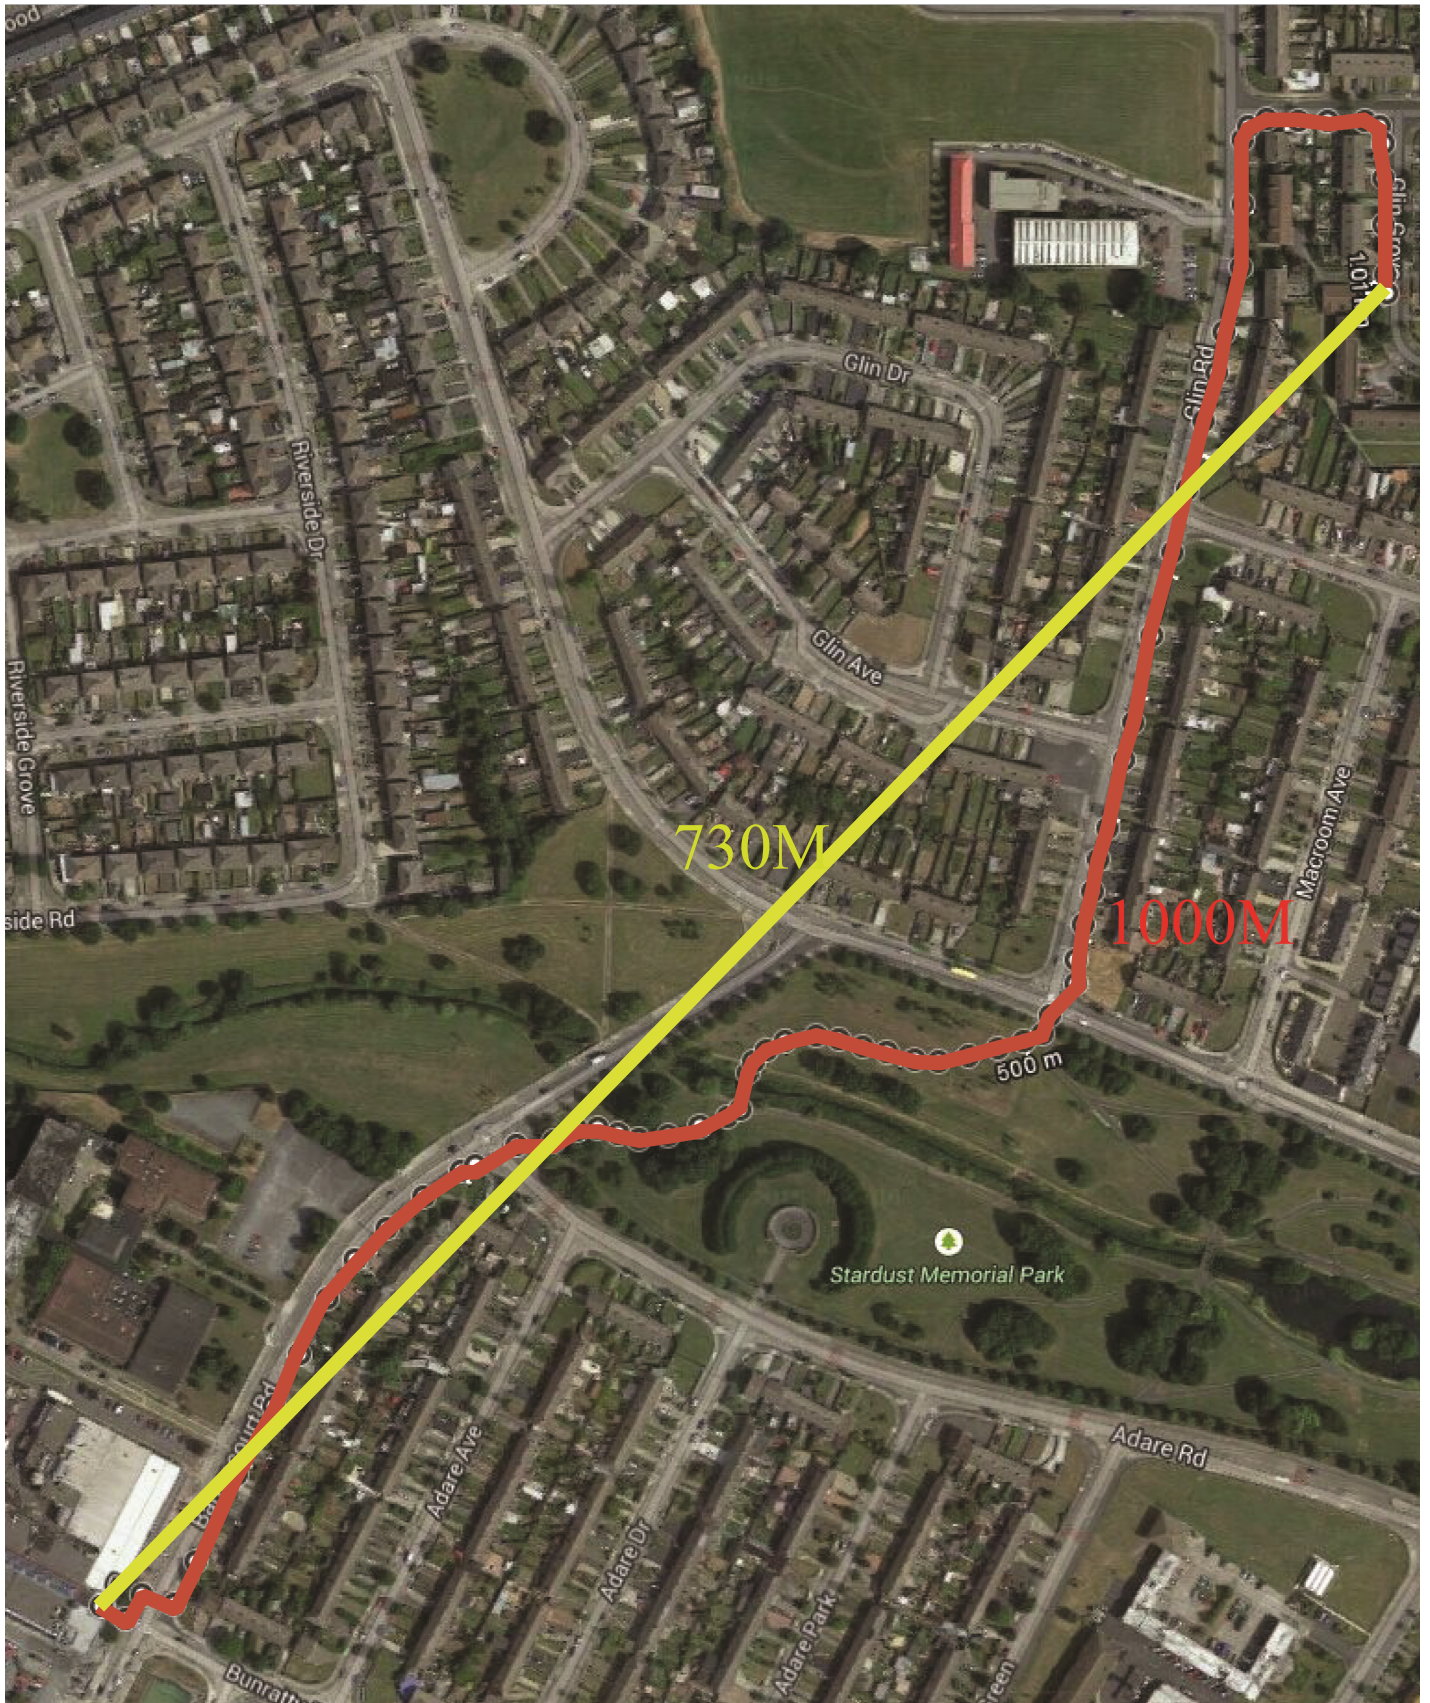
3.6 Permeability Index

$$1000/730=1.37$$

The Permeability Index for this 10 Minutes Pedestrian Catchment is 1.37.

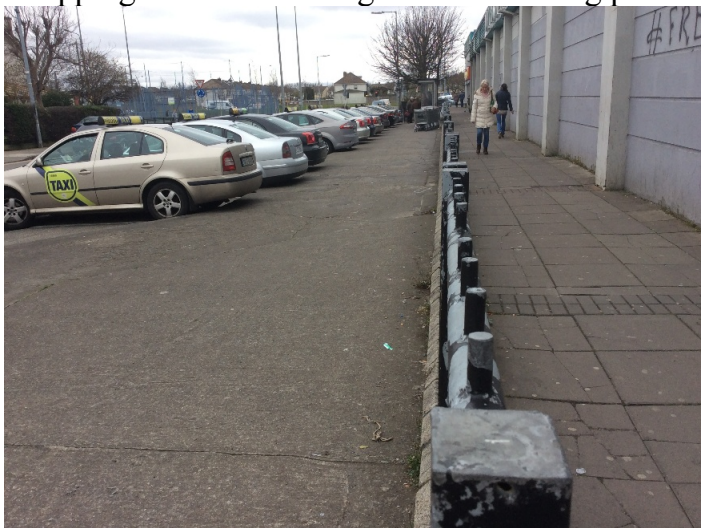
There is a well-designed taxi car park located the front entrance of Northside Shopping Centre. Showing in the following photo.
